# **FERNIE ALPINE RESORT UTILITIES CORPORATION**

Facility Number 12-123-00210

## **2025 ANNUAL WATER REPORT TO INTERIOR HEALTH**

Date of Issue: June 2026

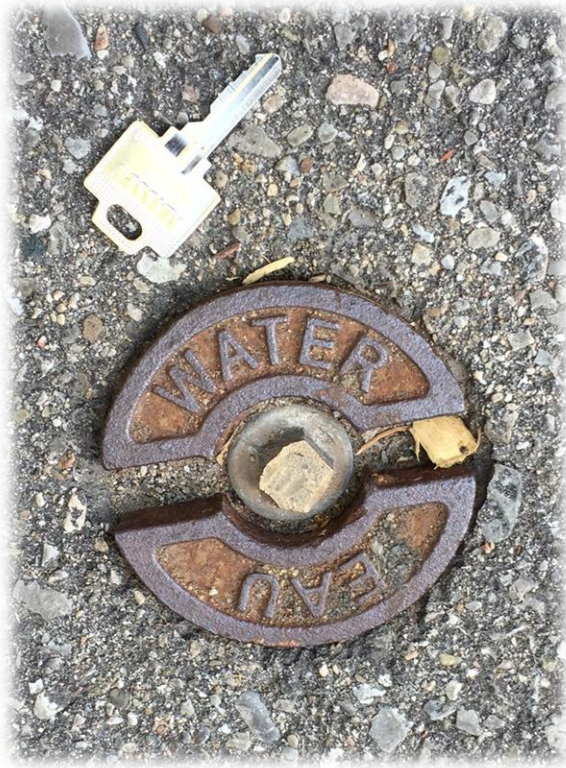
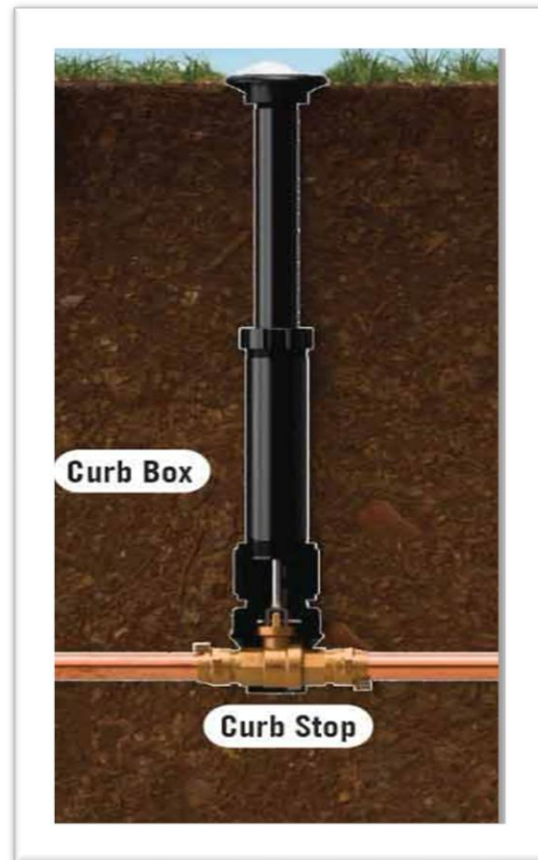
Every home has a curbstop; this is the valve that controls flow from the water distribution system into your home. Normally curbstops are only closed if your interior water shutoff fails or is leaking, or if the home is left vacant for months, to prevent any major leaks while the homeowner is absent. Because the actual operating valve is buried several feet in the ground (please refer to the drawing below), rust over time can cause the curbstop to fail. We understand that this can be expected with aging infrastructure and, if required, we will repair your curbstop as soon as possible. However, we cannot assume responsibility for damaged or buried curbstops. Only FARUC staff are permitted to operate curbstops but we encourage all

homeowners to know where their curbstop is located, in case of an emergency. Your curbstop can be found on the edge of your property easement and should be either flush with the ground or raised slightly (please refer to photo below).
